SUBJECT: The Heights of Crownridge

Lots 2-4 Hays Hills - RW #12 Site Retaining Wall Analysis

San Antonio, Texas (Project No. 11-011)

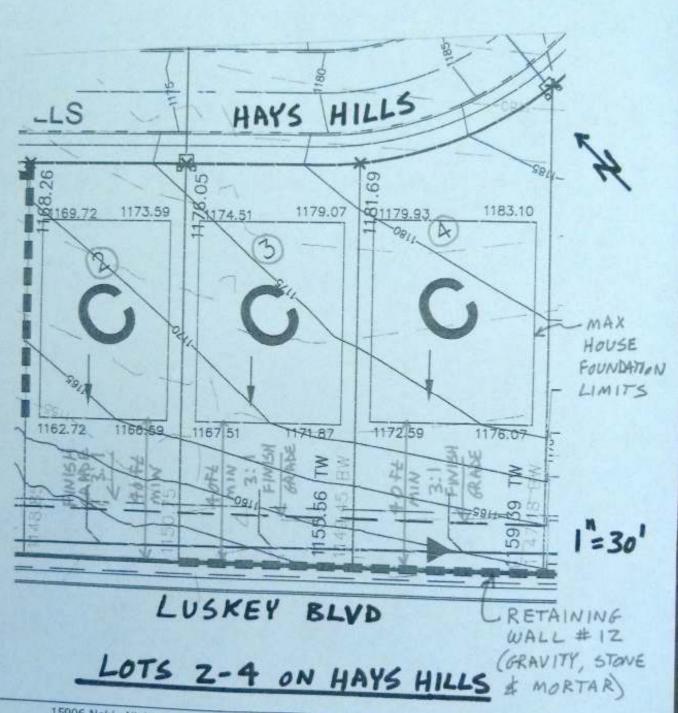
SUBJECT: Partial Site Plan for Lots 2-4 Hays Hills DATE: 7/19/11 SHEET: 3 of 3

I have included a marked-up version of the Carter Burgess grading plan sheet GR2 to indicate the house foundation location requirements for Lots 2-4. Based on these foundation requirements being met, my review of the site conditions above the wall, the condition of the wall and the lack of additional planned loading that will influence the wall, the wall appears to have been built per plans and appears to meet the design intent. It should be noted that this conclusion is based on no destructive testing of the wall or exposure of the back of the wall.
